Report Index

101 FILE NAME: SAMPLE.
 102 CLIENT NAME: Jane Client.
 103 INSPECTION PROPERTY ADDRESS: 000 Any Street
 Anytown, IL 60000.

104 MAIN ENTRY: Faces: South.
 105 STRUCTURE: Standard wood frame construction with a masonry veneer. Raised ranch, single family residence.

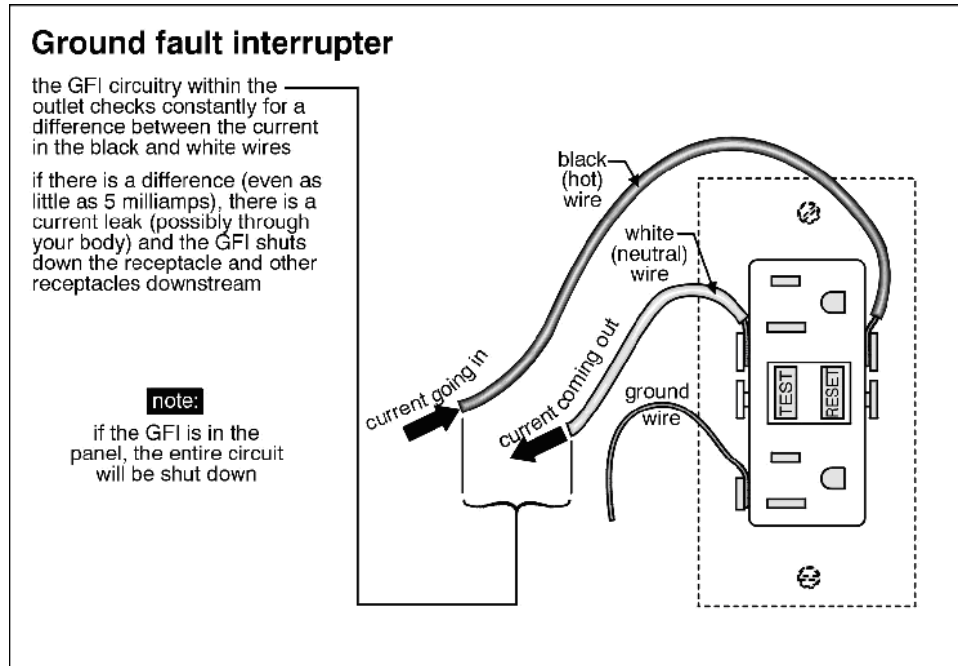
**805
RECEPTACLES:**

The accessible receptacles were serviceable, with the following exceptions noted;

- a. [RU] The accessible receptacles were serviceable, they were not GFCI protected. We recommend upgrading to provide GFCI protection for the receptacles for safety reasons.

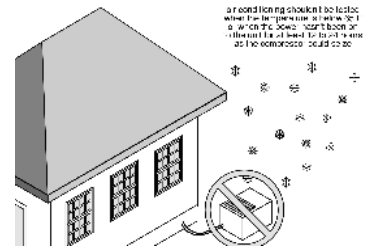
Don't test when it's cold

[FE] The outside air temperature was below 60 degrees. Operating the system under these conditions could damage the condensing unit compressor. We recommend having the system checked by a specialist in the appropriate trade when the outside air temperature has been above 65 degrees for a period of time.
